Field Report for Airborne Data Collected In Support of US EPA Region 6 South 4 Group Fire 04 December 2019

The US EPA Region 6 requested that the ASPECT system be deployed to provide monitoring support beginning on 27 November 2019. This report summarizes findings observed during the two missions flown on 04 December 2019.

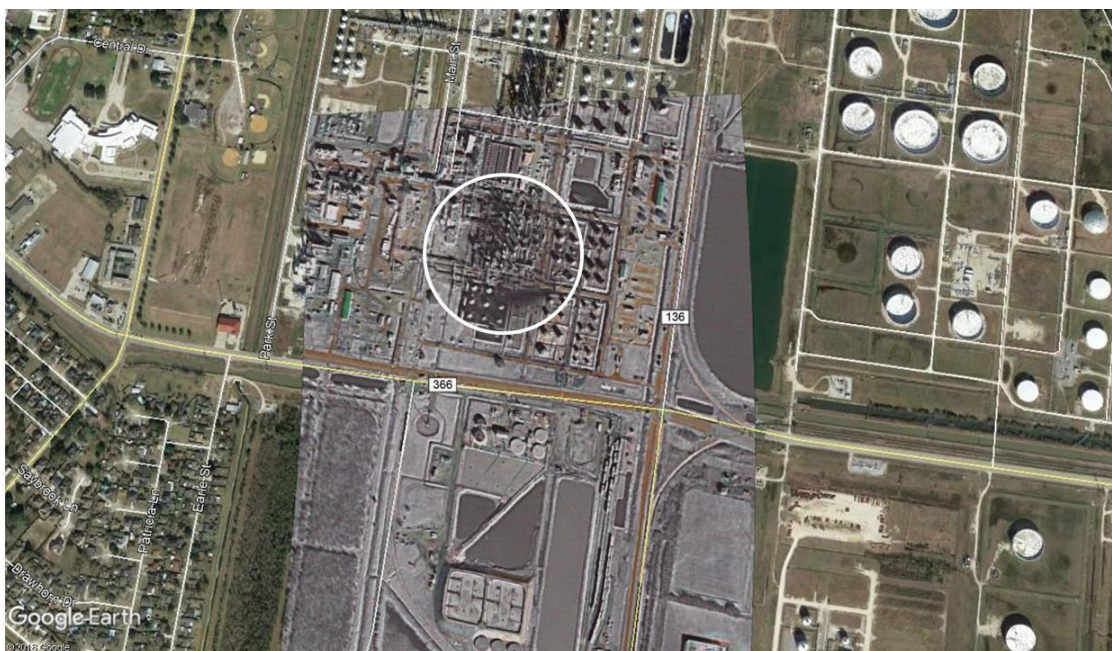
Figure 3: – 3 band IR image, Flight 14, Run 8, South 4 Group Fire

A total of 1 test and 8 data collection passes were made in the proximity of the fire and an infrared line scanner image was generated for each pass. Figure 3 shows a typical 3-band infrared image obtained from data collected for Run 2. The thermal environment of the unit continues to be low. At the time of the IR collection, a water cannon was being used to spray a spherical tank south of the production unit, but no water was being applied to the unit proper. No emissions were detected in the IR imagery. Figure 4 shows a close-up thermal analysis of the production facility. Solar heating of tanks and metal surfaces is evident in the image. A cool spray of water can be seen being directed to a spherical tank south of the unit with that tank much cooler than the neighboring vessels. No significantly elevated temperature sources are present in the image.

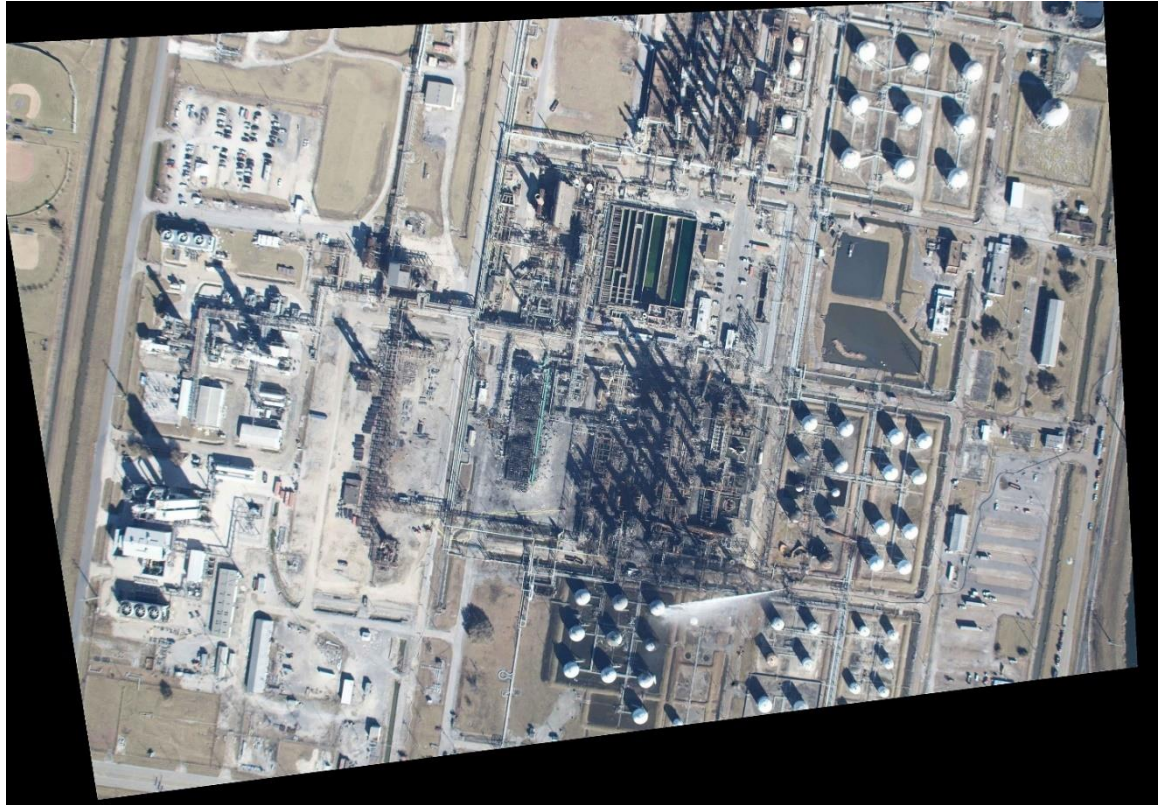
Figure 5: Aerial Image, Flight 14, Run 6, South 4 Group Fire.

A full set of high resolution aerial digital photography were collected as part of the flight. Figure 5 shows a representative image collected as part of each pass. Smoke is not evident in the image and only one water cannon can be observed being directed on the spherical tank south of the unit. The oblique image in Figure 6 shows a detail of the cannon use on the spherical tank.

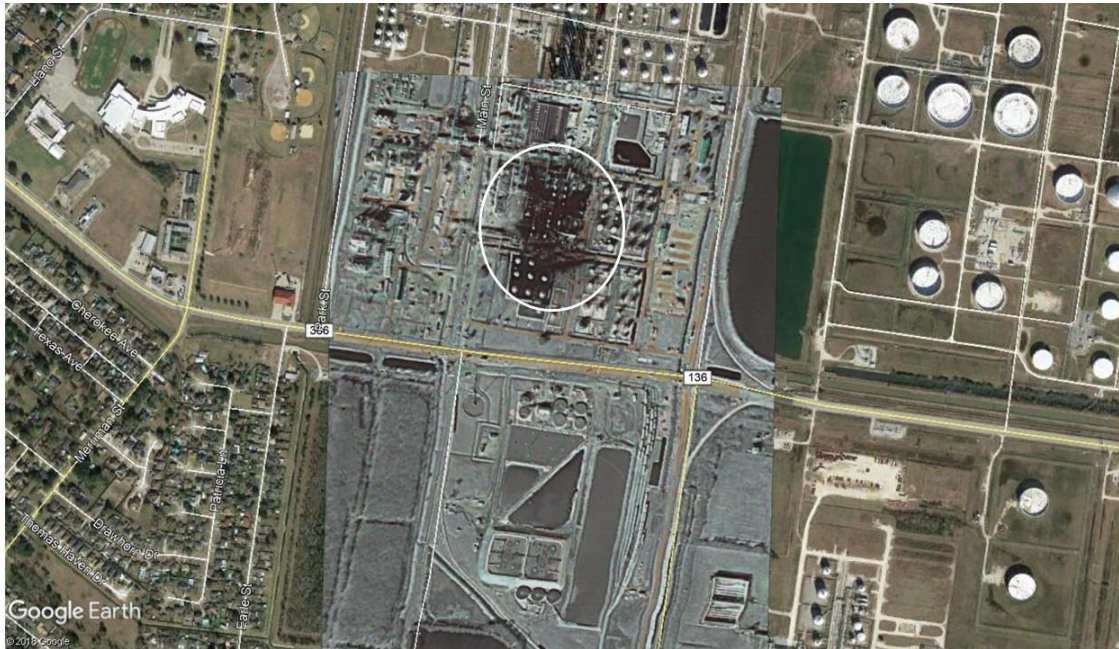
Figure 8: – 3 band IR image, Flight 15, Run 2, South 4 Group Fire

A total of 1 test and 8 data collection passes were made in the proximity of the fire and an infrared line scanner image was generated for each pass. Figure 8 shows a 3-band infrared image obtained from data collected for Run 2. Examination of the image shows no significant elevated thermal locations on this collection pass. The white signatures seen on the tanks and metal structures are due to solar heating. No chemical plume was observed in the frame. Figure 9 shows a close-up of the process unit collected on Run 5. The most significant signature is that of the water spray and the cooling effect for the entire process unit. It should be noted that the water spray on the spherical tank has cooled to the tank to the same approximate temperature as the water. To check for possible oil sheen presence on the Naches River, ASPECT was flown along the waterway leading into the river. Figure 10 shows an IR image of the waterway/river confluence with no signature of oil sheen.

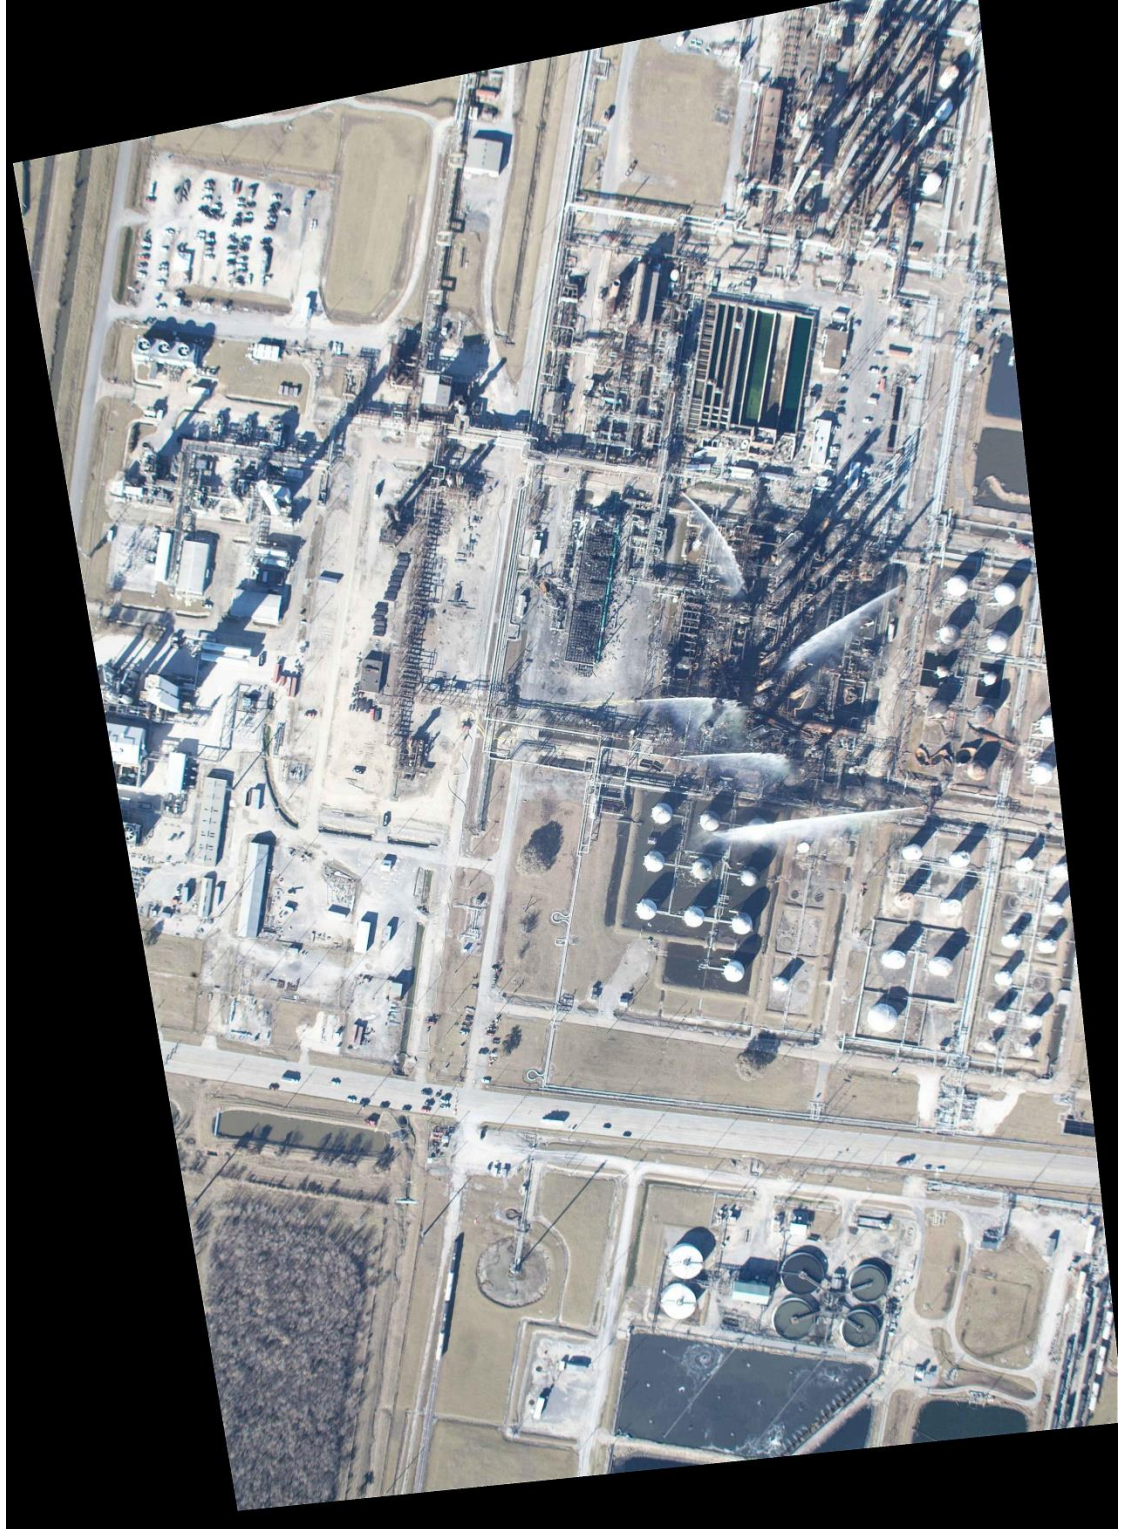
Figure 11: Aerial Image of the South 4Group Fire, Flight 15

A full set of high resolution aerial digital photography were collected as part of the flight. Figure 11 shows a representative image collected as part of each pass. Visible data mirrors that of the IR in that no smoke can be seen being emitted from the facility. At the time of the visible collection, in a similar fashion as the morning flight no smoke was observed being emitted from the site. Oblique imagery does show that water cannons continue to be used to flood the process unit (figure 12).
